CAPISIC BROOK WATERSHED

FLOOD PLAIN MANAGEMENT STUDY

Technical Report Summary

OCTOBER 1995

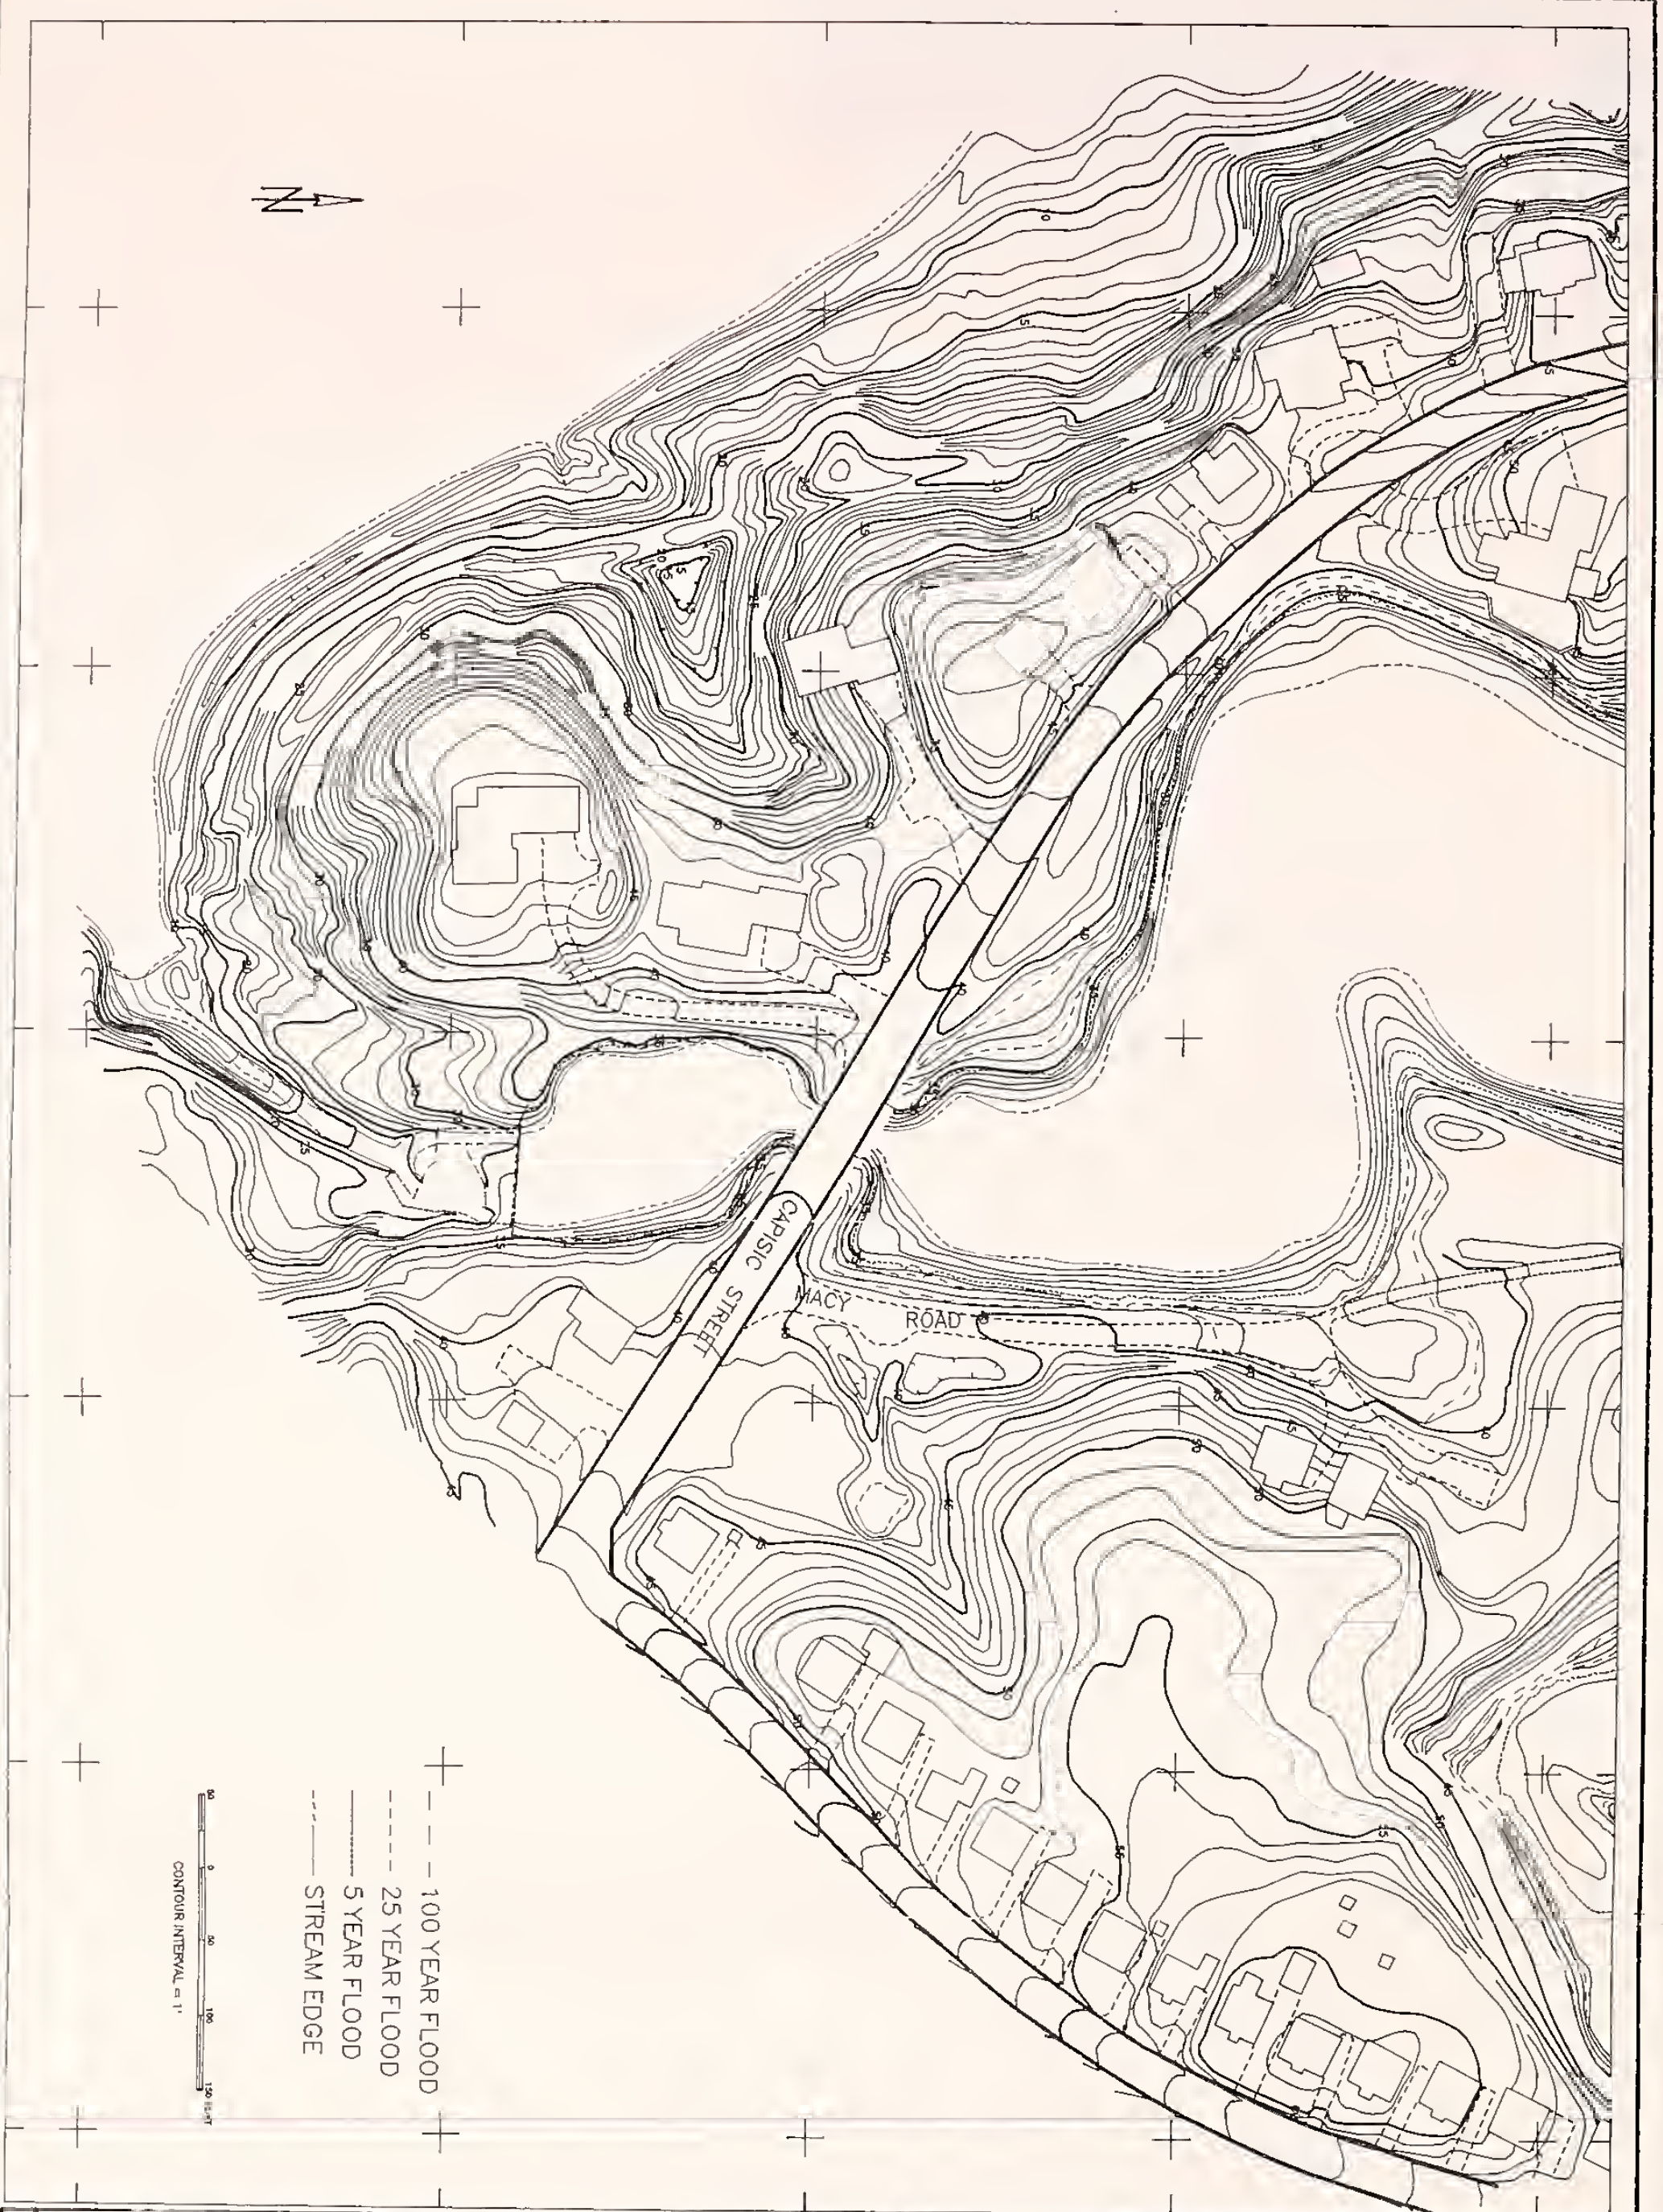
SHEET 10

ORIGINAL DRAWINGS PREPARED BY:
AERIAL SURVEY & PHOTO, INC. NORRIDGEWOCK, MAINE
FROM PHOTOGRAMMETRIC METHODS
FROM AERIAL PHOTOGRAPHS DATED 5-15-92
DIGITIZED BY: CITY OF PORTLAND, MAINE
PARKS & PUBLIC WORKS DEPT.
ENGINEERING DIVISION
FLOOD DELINEATION LINES PRODUCED USING GRASS
(GEOGRAPHIC RESOURCE ANALYSIS SUPPORT SYSTEM)
BY THE NATURAL RESOURCES CONSERVATION SERVICE,
DURHAM, NEW HAMPSHIRE

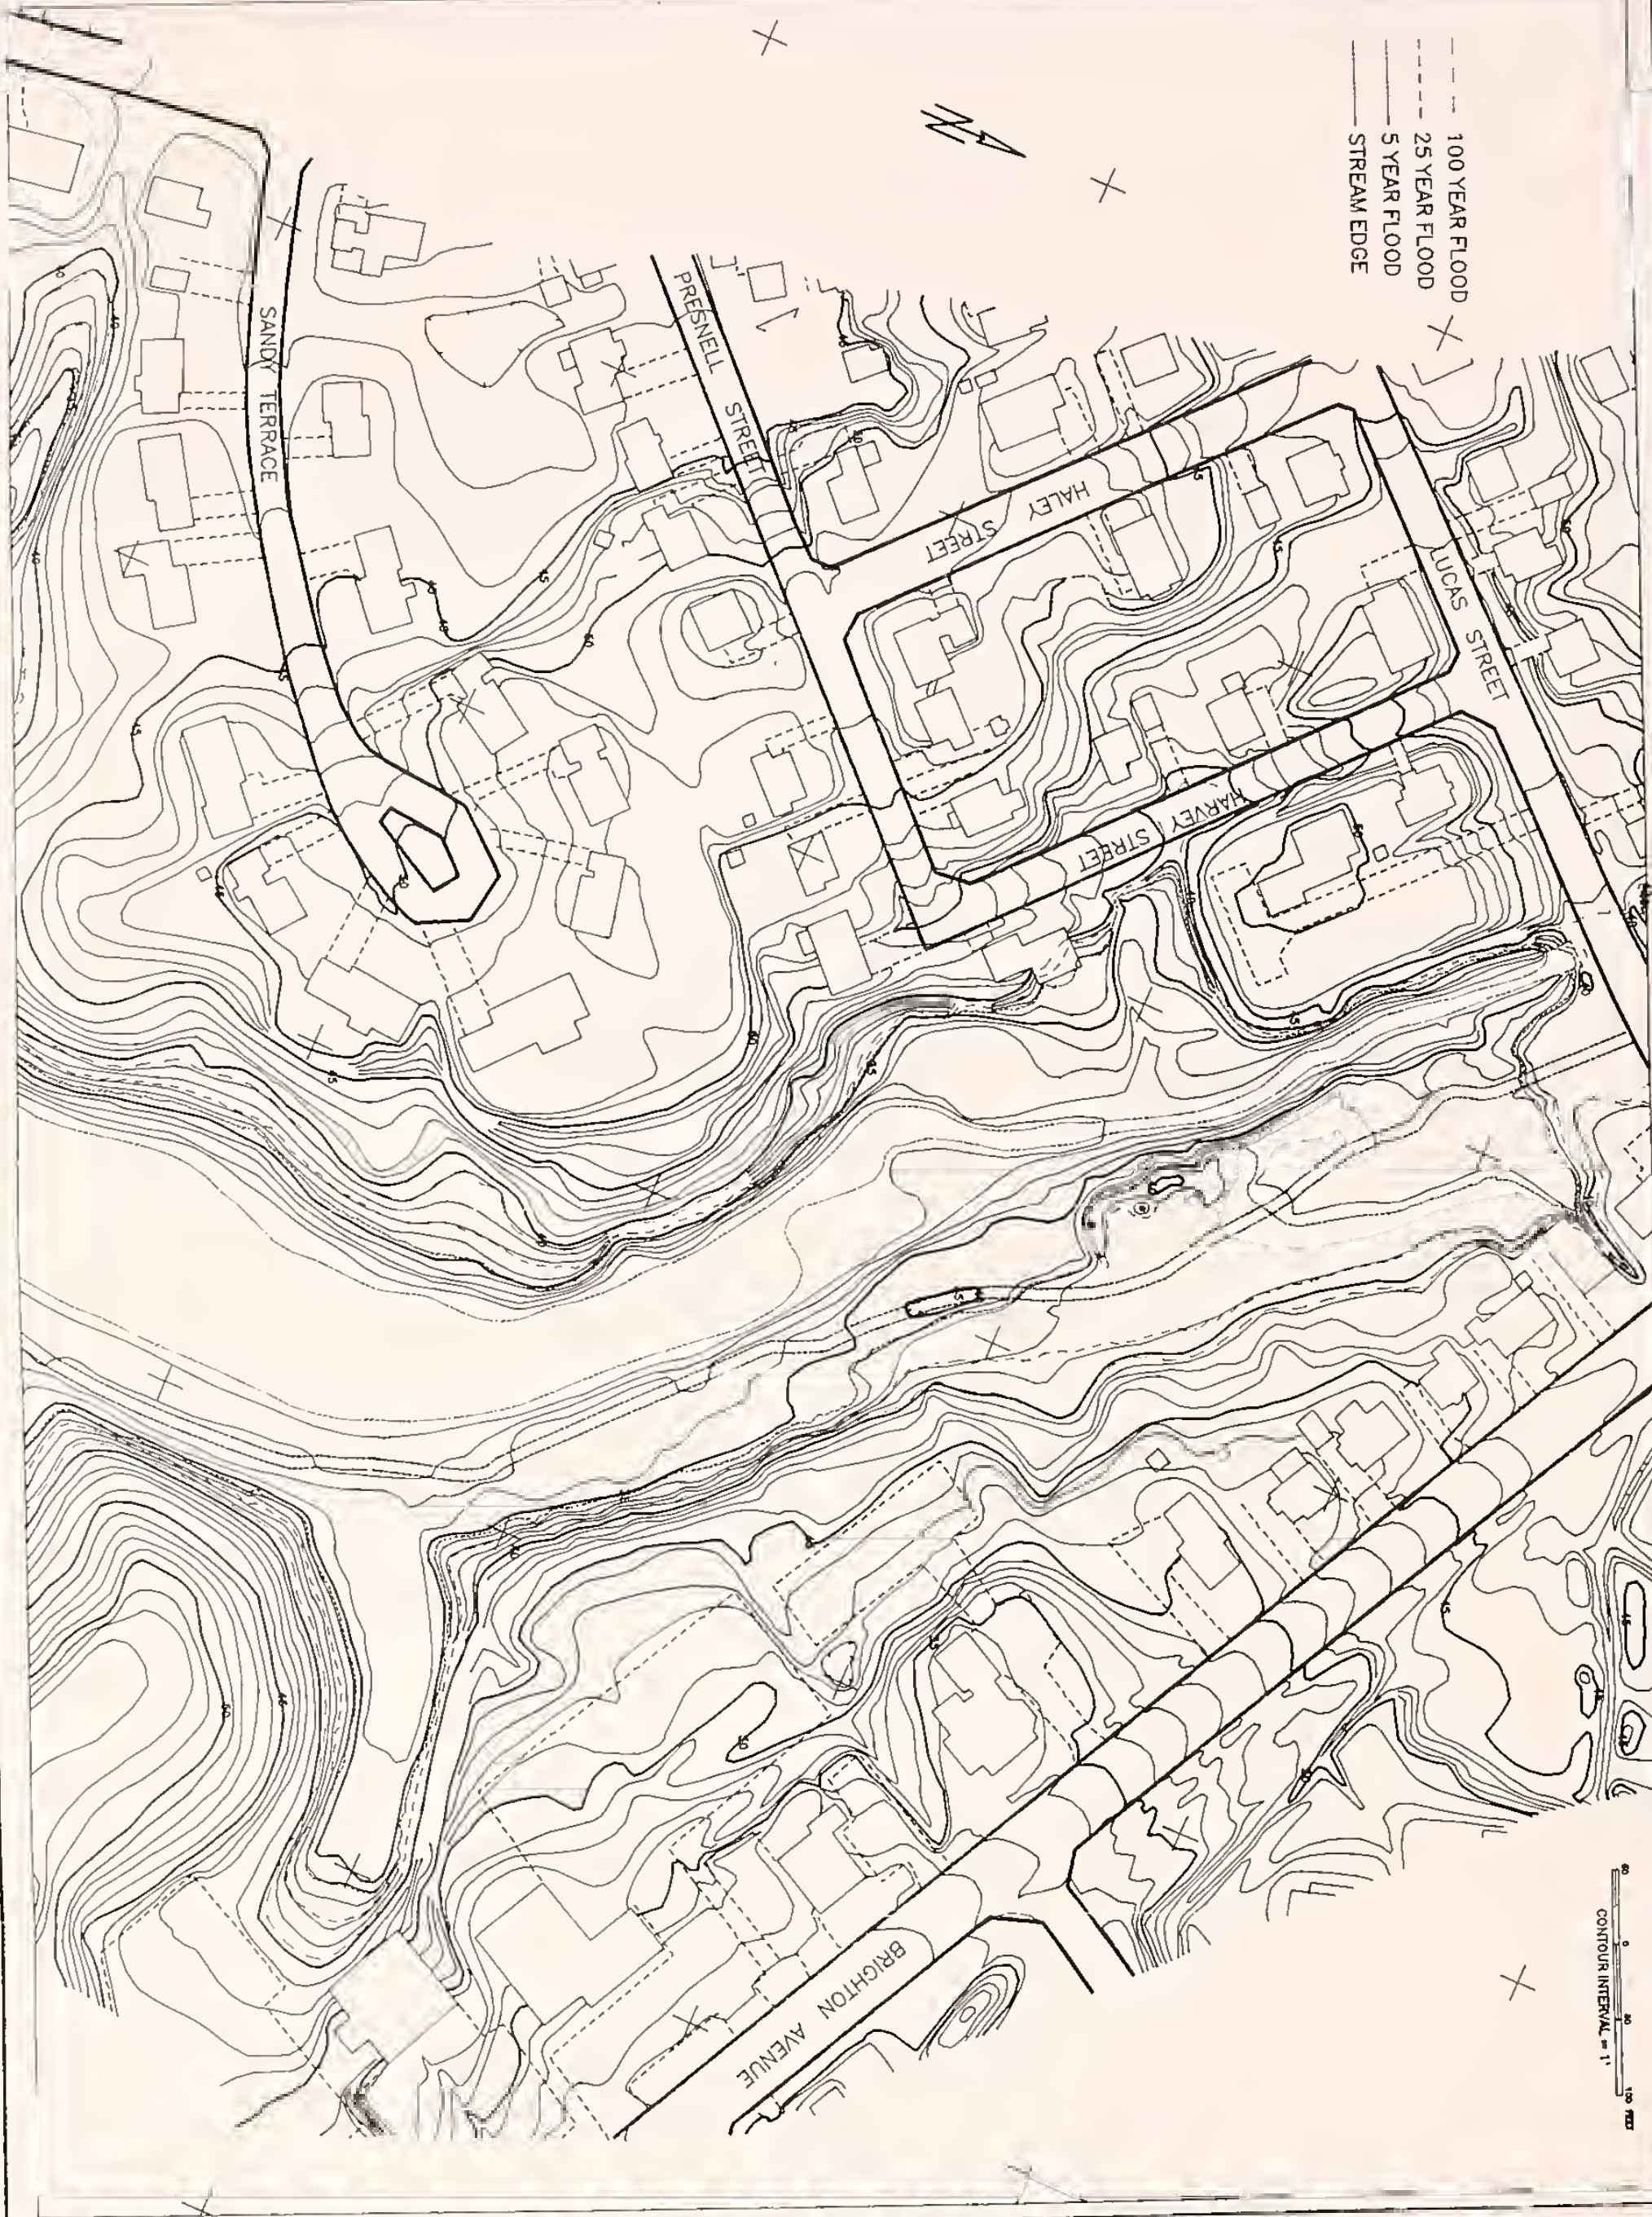
SHEET 12

ORIGINAL DRAWINGS PREPARED BY:
AERIAL SURVEY & PHOTO, INC. NORRIDGEWOCK, MAINE
FROM PHOTOGRAMMETRIC METHODS
FROM AERIAL PHOTOGRAPHS DATED 5-15-92
DIGITIZED BY: CITY OF PORTLAND, MAINE
PARKS & PUBLIC WORKS DEPT.
ENGINEERING DIVISION
FLOOD DELINEATION LINES PRODUCED USING GRASS
(GEODATAPIC RESOURCE ANALYSIS SUPPORT SYSTEM)
BY THE NATURAL RESOURCES CONSERVATION SERVICE,
DURHAM, NEW HAMPSHIRE

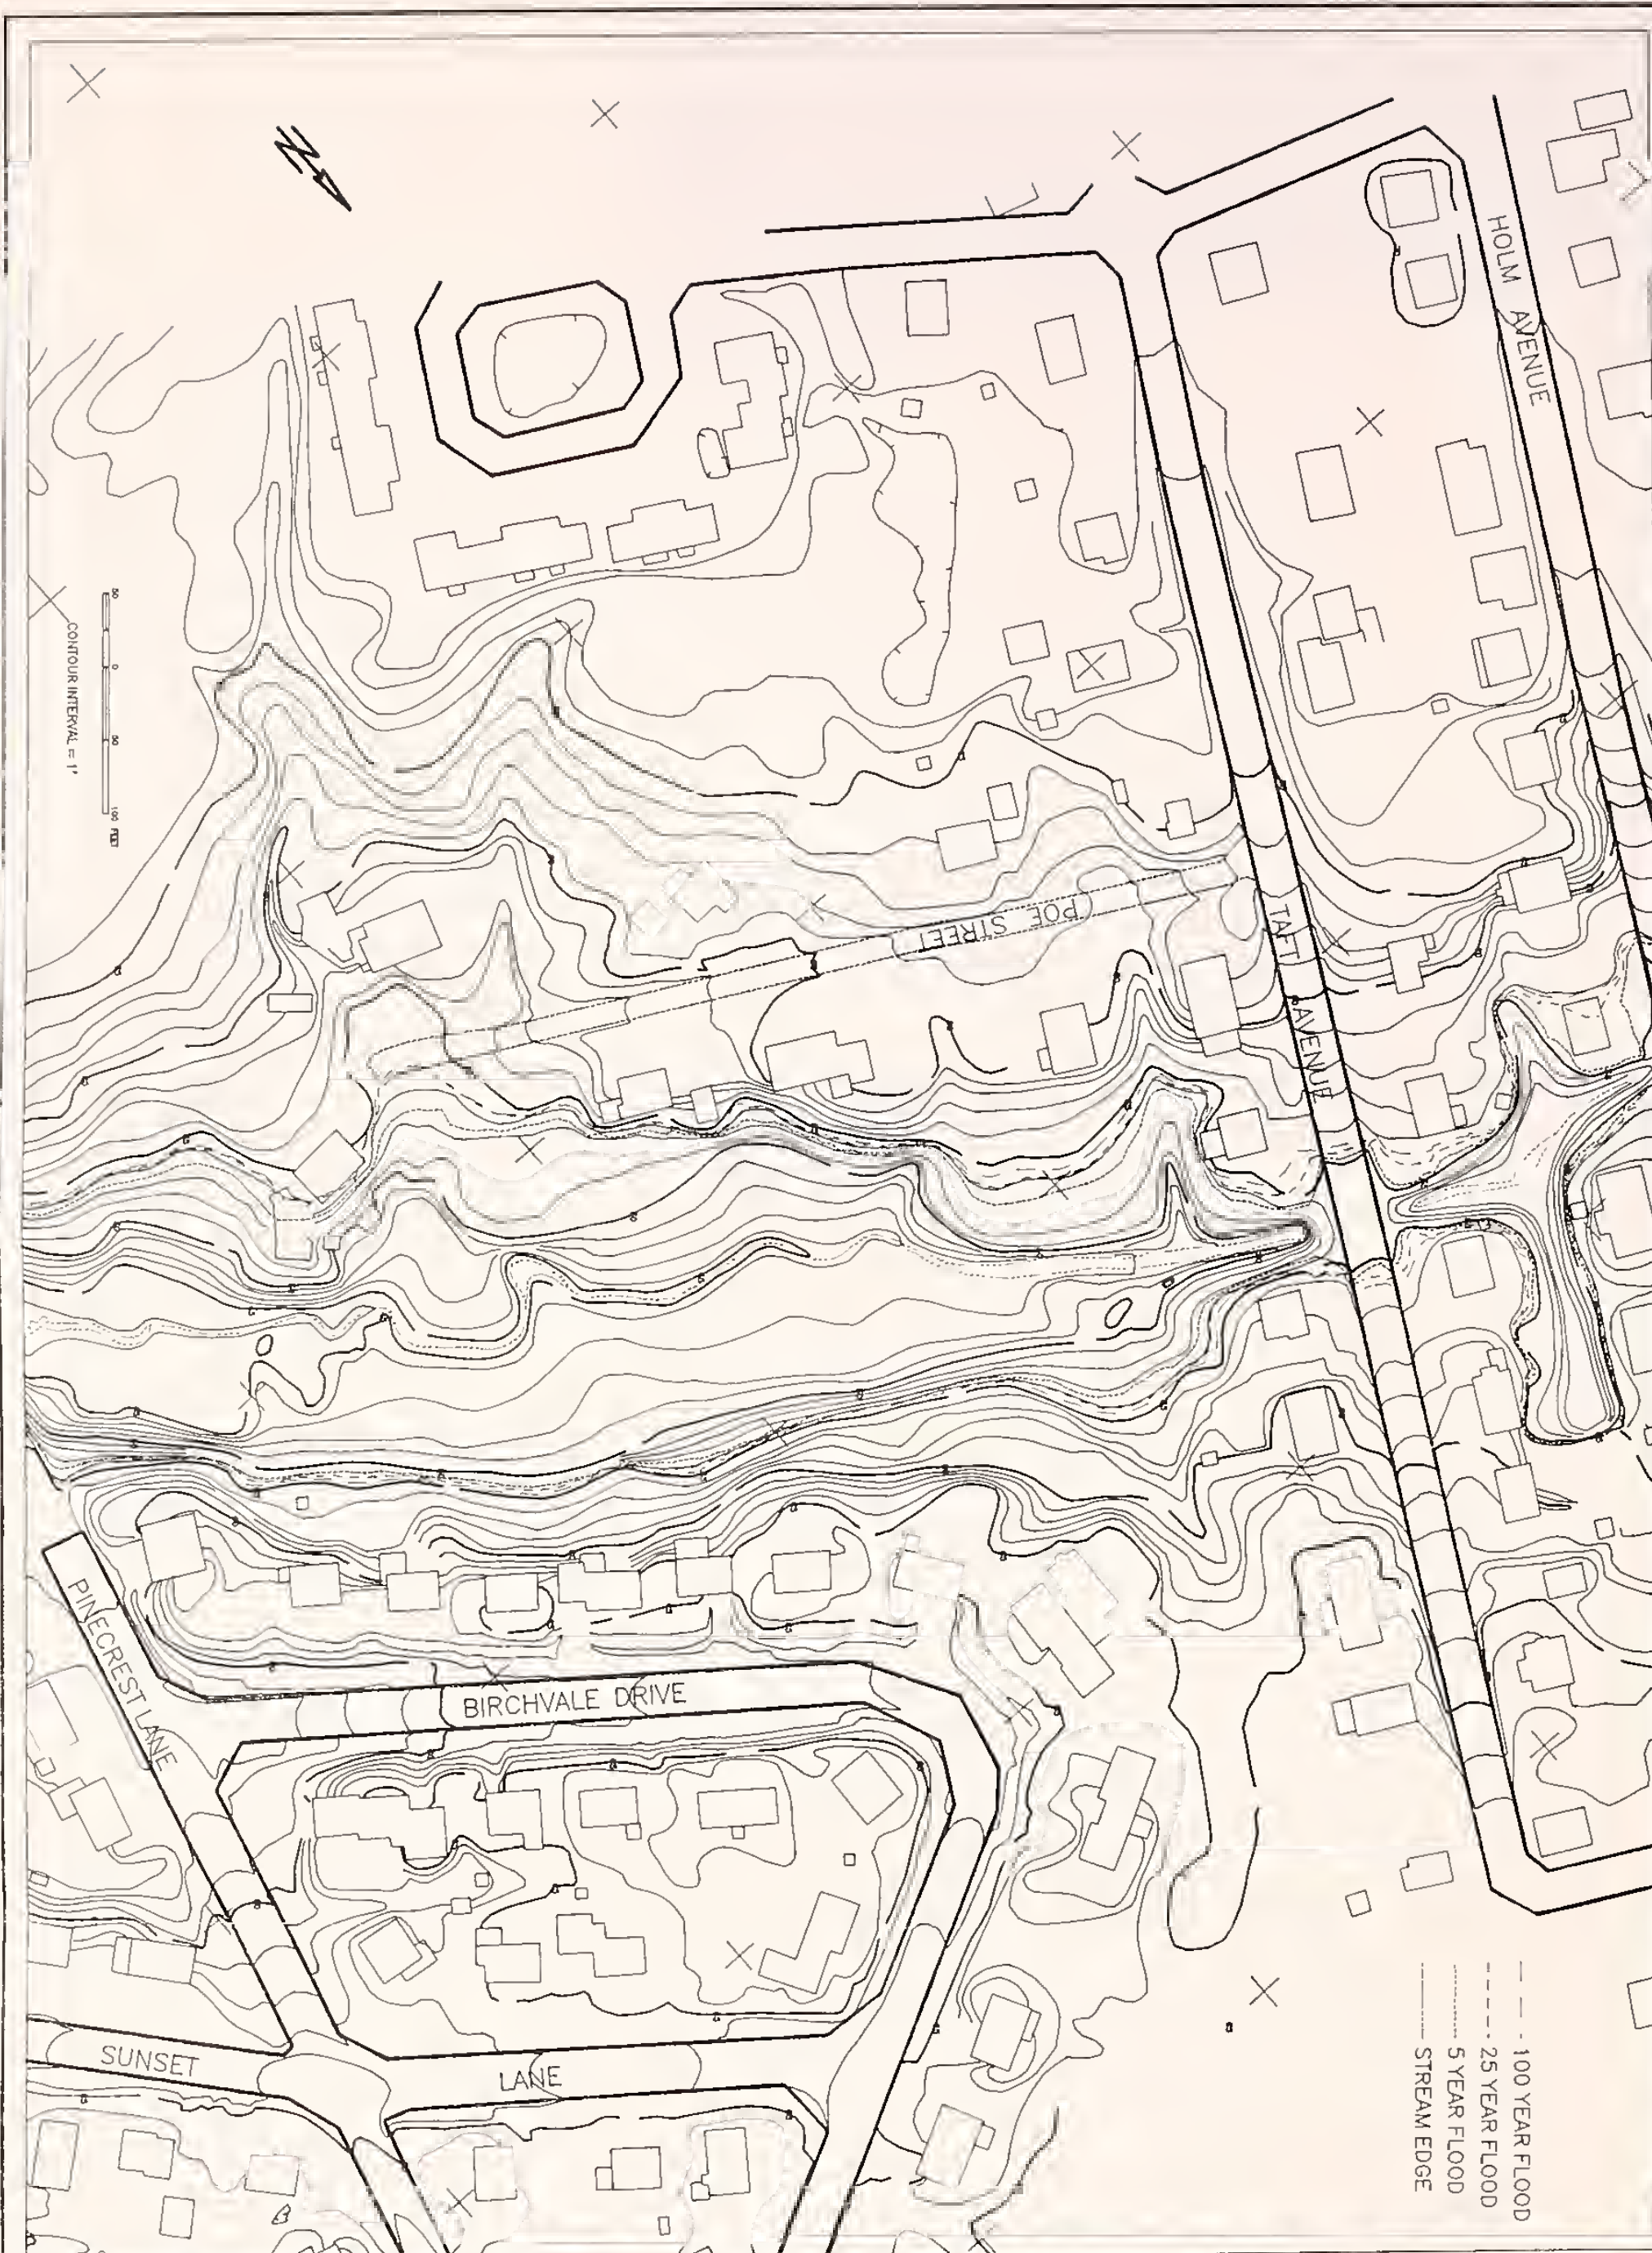
| <div data-bbox="124 2630 176 2963" data-label="Text"><p>SHEET 17</p></div> <div data-bbox="223 2658 710 2833" data-label="Text"><p>NATURAL RESOURCES CONSERVATION SERVICE DURHAM, NEW HAMPSHIRE</p></div> <div data-bbox="229 2866 445 2906" data-label="Text"><p>FEBRUARY, 1995</p></div> | <div data-bbox="878 2664 1272 2754" data-label="Section-Header"><p>CAPISIC BROOK FLOOD PLAIN STUDY</p></div> <div data-bbox="764 2839 1386 2927" data-label="Text"><p>VERTICAL DATUM — NATIONAL GEODETIC VERTICAL DATUM (1929) HORIZONTAL DATUM — MAINE STATE PLANE COORDINATE SYSTEM (WEST ZONE) 5DD' GRID</p></div> | <div data-bbox="1446 2646 1968 2942" data-label="Text"><p>ORIGINAL DRAWINGS PREPARED BY: AERIAL SURVEY & PHOTO, INC. NORRIDGEWOCK, MAINE FROM PHOTOGRAMMETRIC METHODS FROM AERIAL PHOTOGRAPHS DATED 5-15-92 DIGITIZED BY: CITY OF PORTLAND, MAINE PARKS & PUBLIC WORKS DEPT. ENGINEERING DIVISION FLOOD DELINEATION LINES PRODUCED USING GRASS (GEOGRAPHIC RESOURCE ANALYSIS SUPPORT SYSTEM) BY THE NATURAL RESOURCES CONSERVATION SERVICE, DURHAM, NEW HAMPSHIRE</p></div> |

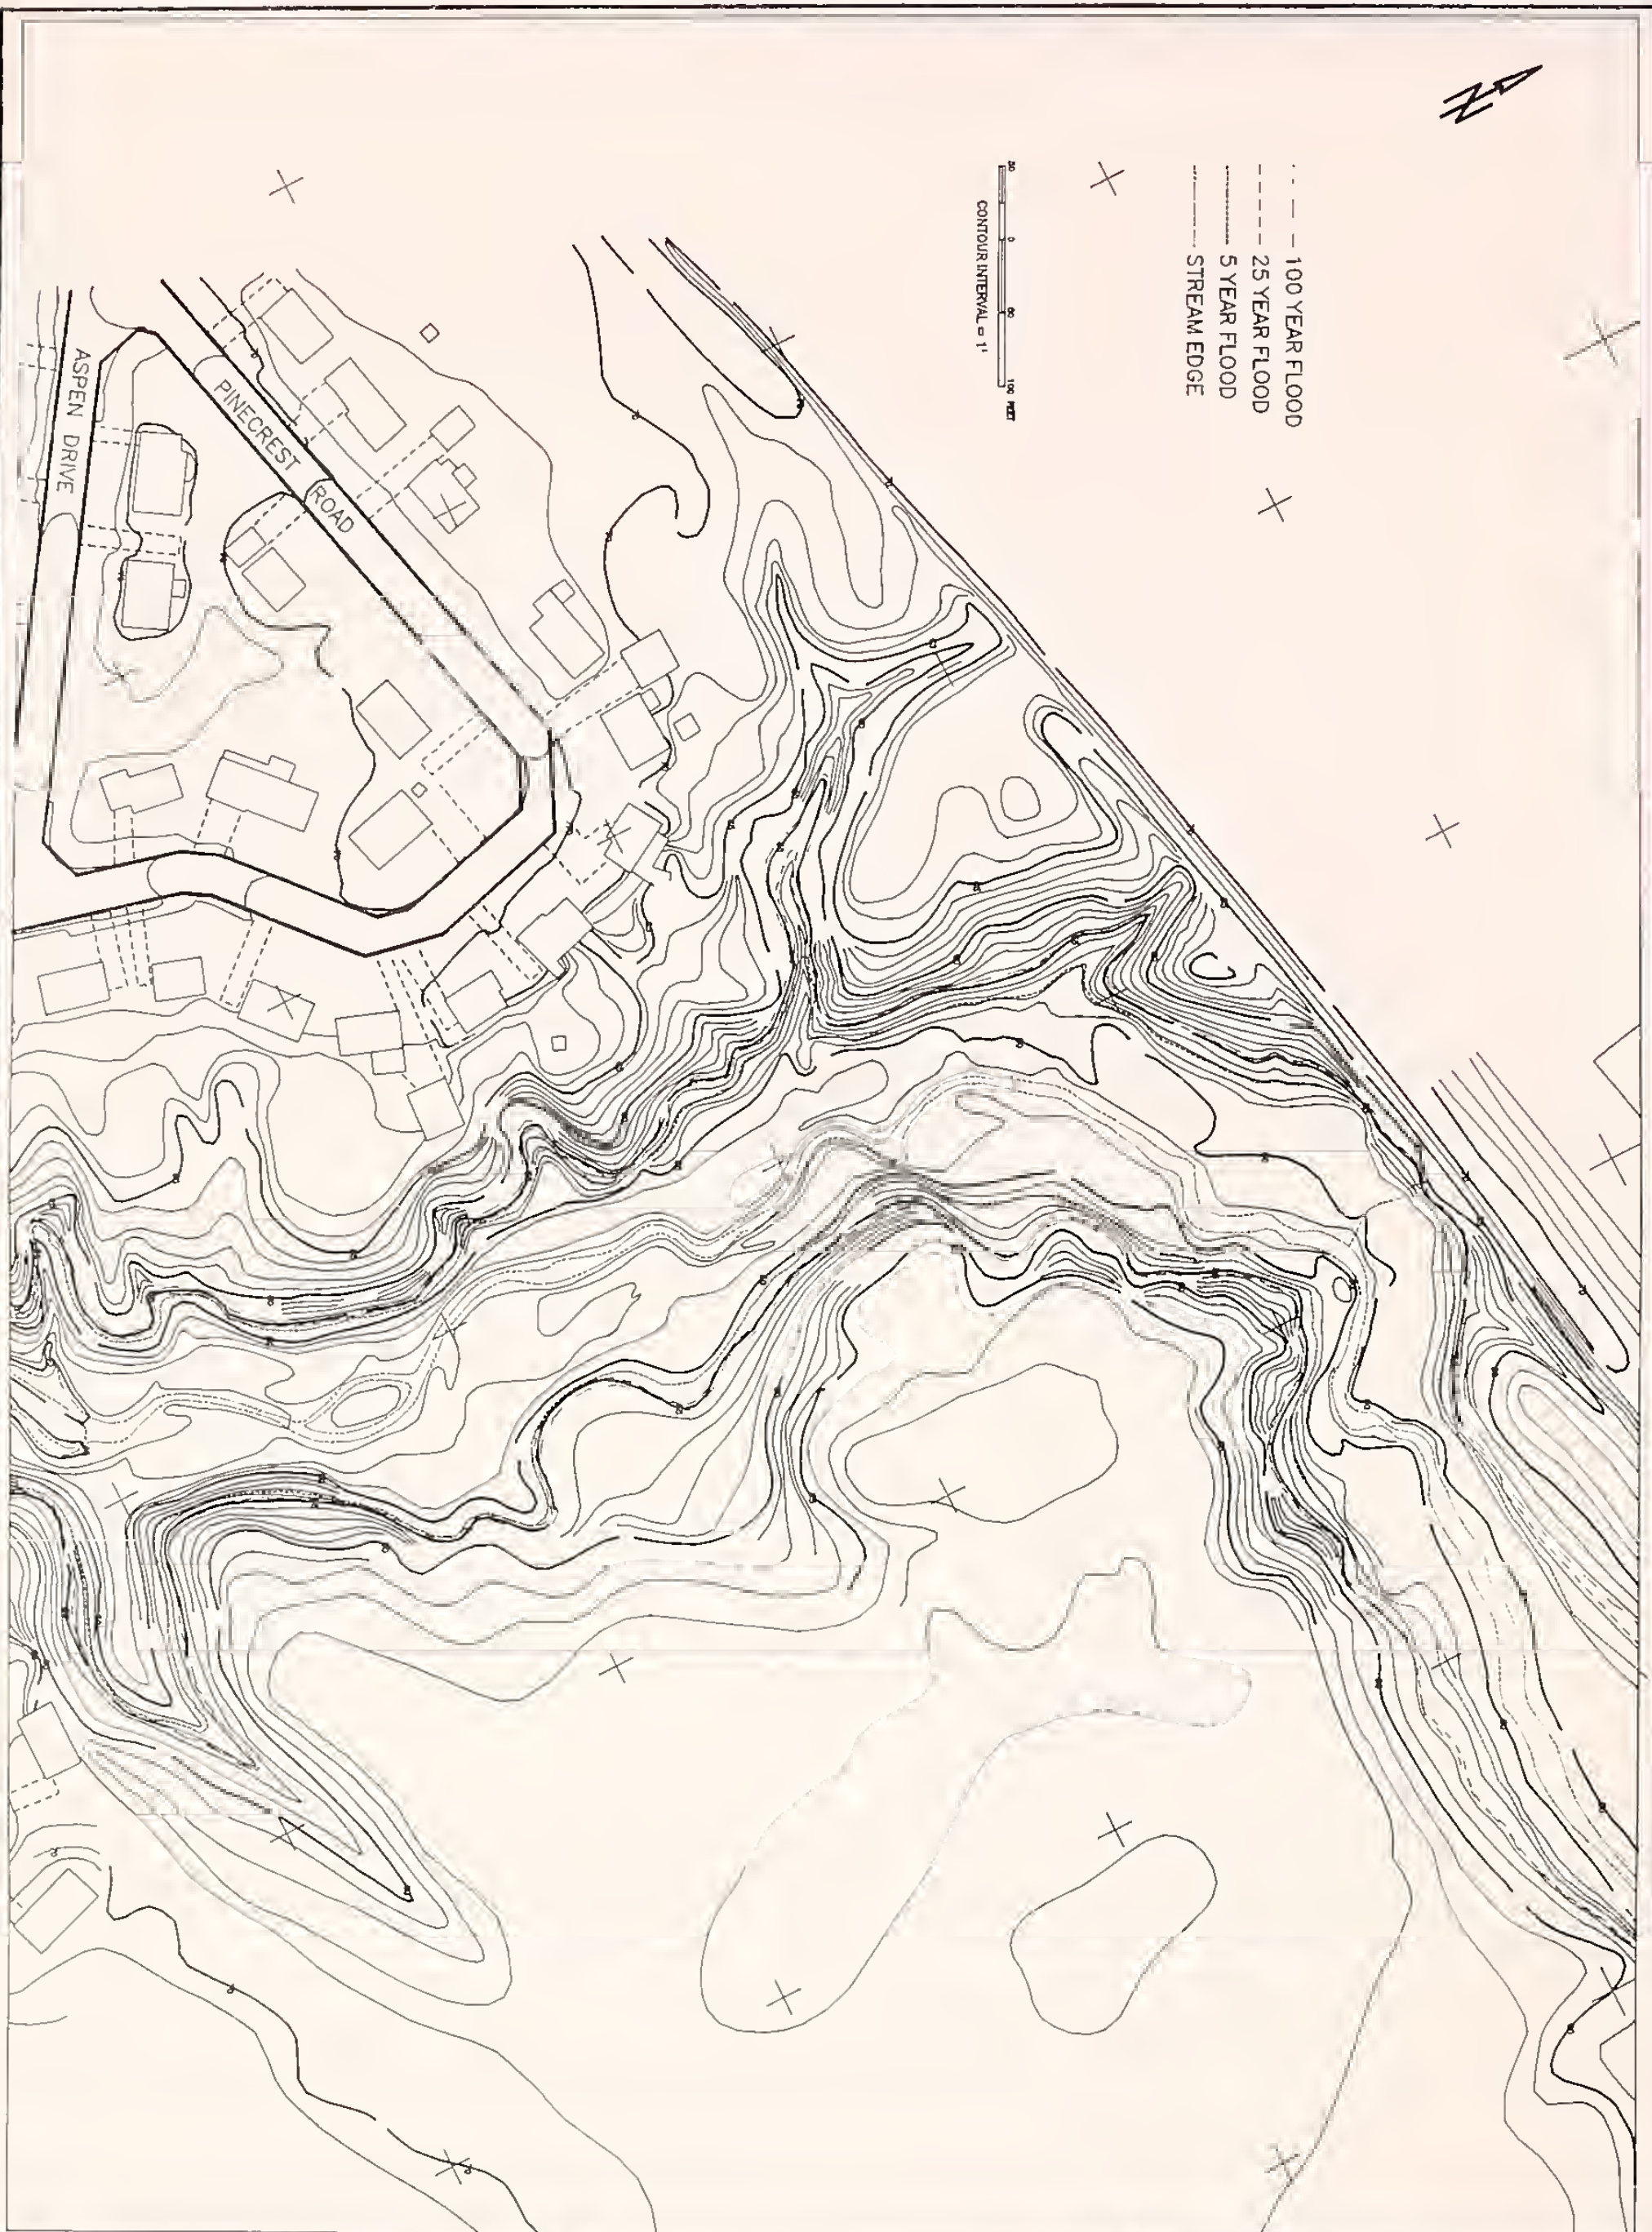
| <div data-bbox="62 2736 103 2887" data-label="Page-Footer"><p>SHEET 20</p></div> <div data-bbox="176 2676 673 2857" data-label="Text"><p>NATURAL RESOURCES CONSERVATION SERVICE DURHAM, NEW HAMPSHIRE</p></div> <div data-bbox="186 2887 404 2933" data-label="Text"><p>FEBRUARY, 1995</p></div> | <div data-bbox="849 2676 1253 2782" data-label="Section-Header"><p>CAPISIC BROOK FLOOD PLAIN STUDY</p></div> <div data-bbox="725 2857 1367 2948" data-label="Text"><p>VERTICAL DATUM - NATIONAL GEODETIC VERTICAL DATUM (1929) HORIZONTAL DATUM - MAINE STATE PLANE COORDINATE SYSTEM (WEST ZONE) 500' GRID</p></div> | <div data-bbox="1398 2661 1947 2721" data-label="Text"><p>ORIGINAL DRAWINGS PREPARED BY: AERIAL SURVEY & PHOTO, INC. NORRIDGEWOCK, MAINE</p></div> <div data-bbox="1398 2721 1875 2782" data-label="Text"><p>FROM PHOTOGRAMMETRIC METHODS FROM AERIAL PHOTOGRAPHS DATED 5-15-92</p></div> <div data-bbox="1398 2782 1813 2857" data-label="Text"><p>DIGITIZED BY: CITY OF PORTLAND, MAINE PARKS & PUBLIC WORKS DEPT. ENGINEERING DIVISION</p></div> <div data-bbox="1398 2857 1968 2963" data-label="Text"><p>FLOOD DELINEATION LINES PRODUCED USING GRASS (GEOGRAPHIC RESOURCE ANALYSIS SUPPORT SYSTEM) BY THE NATURAL RESOURCES CONSERVATION SERVICE, DURHAM, NEW HAMPSHIRE</p></div> |

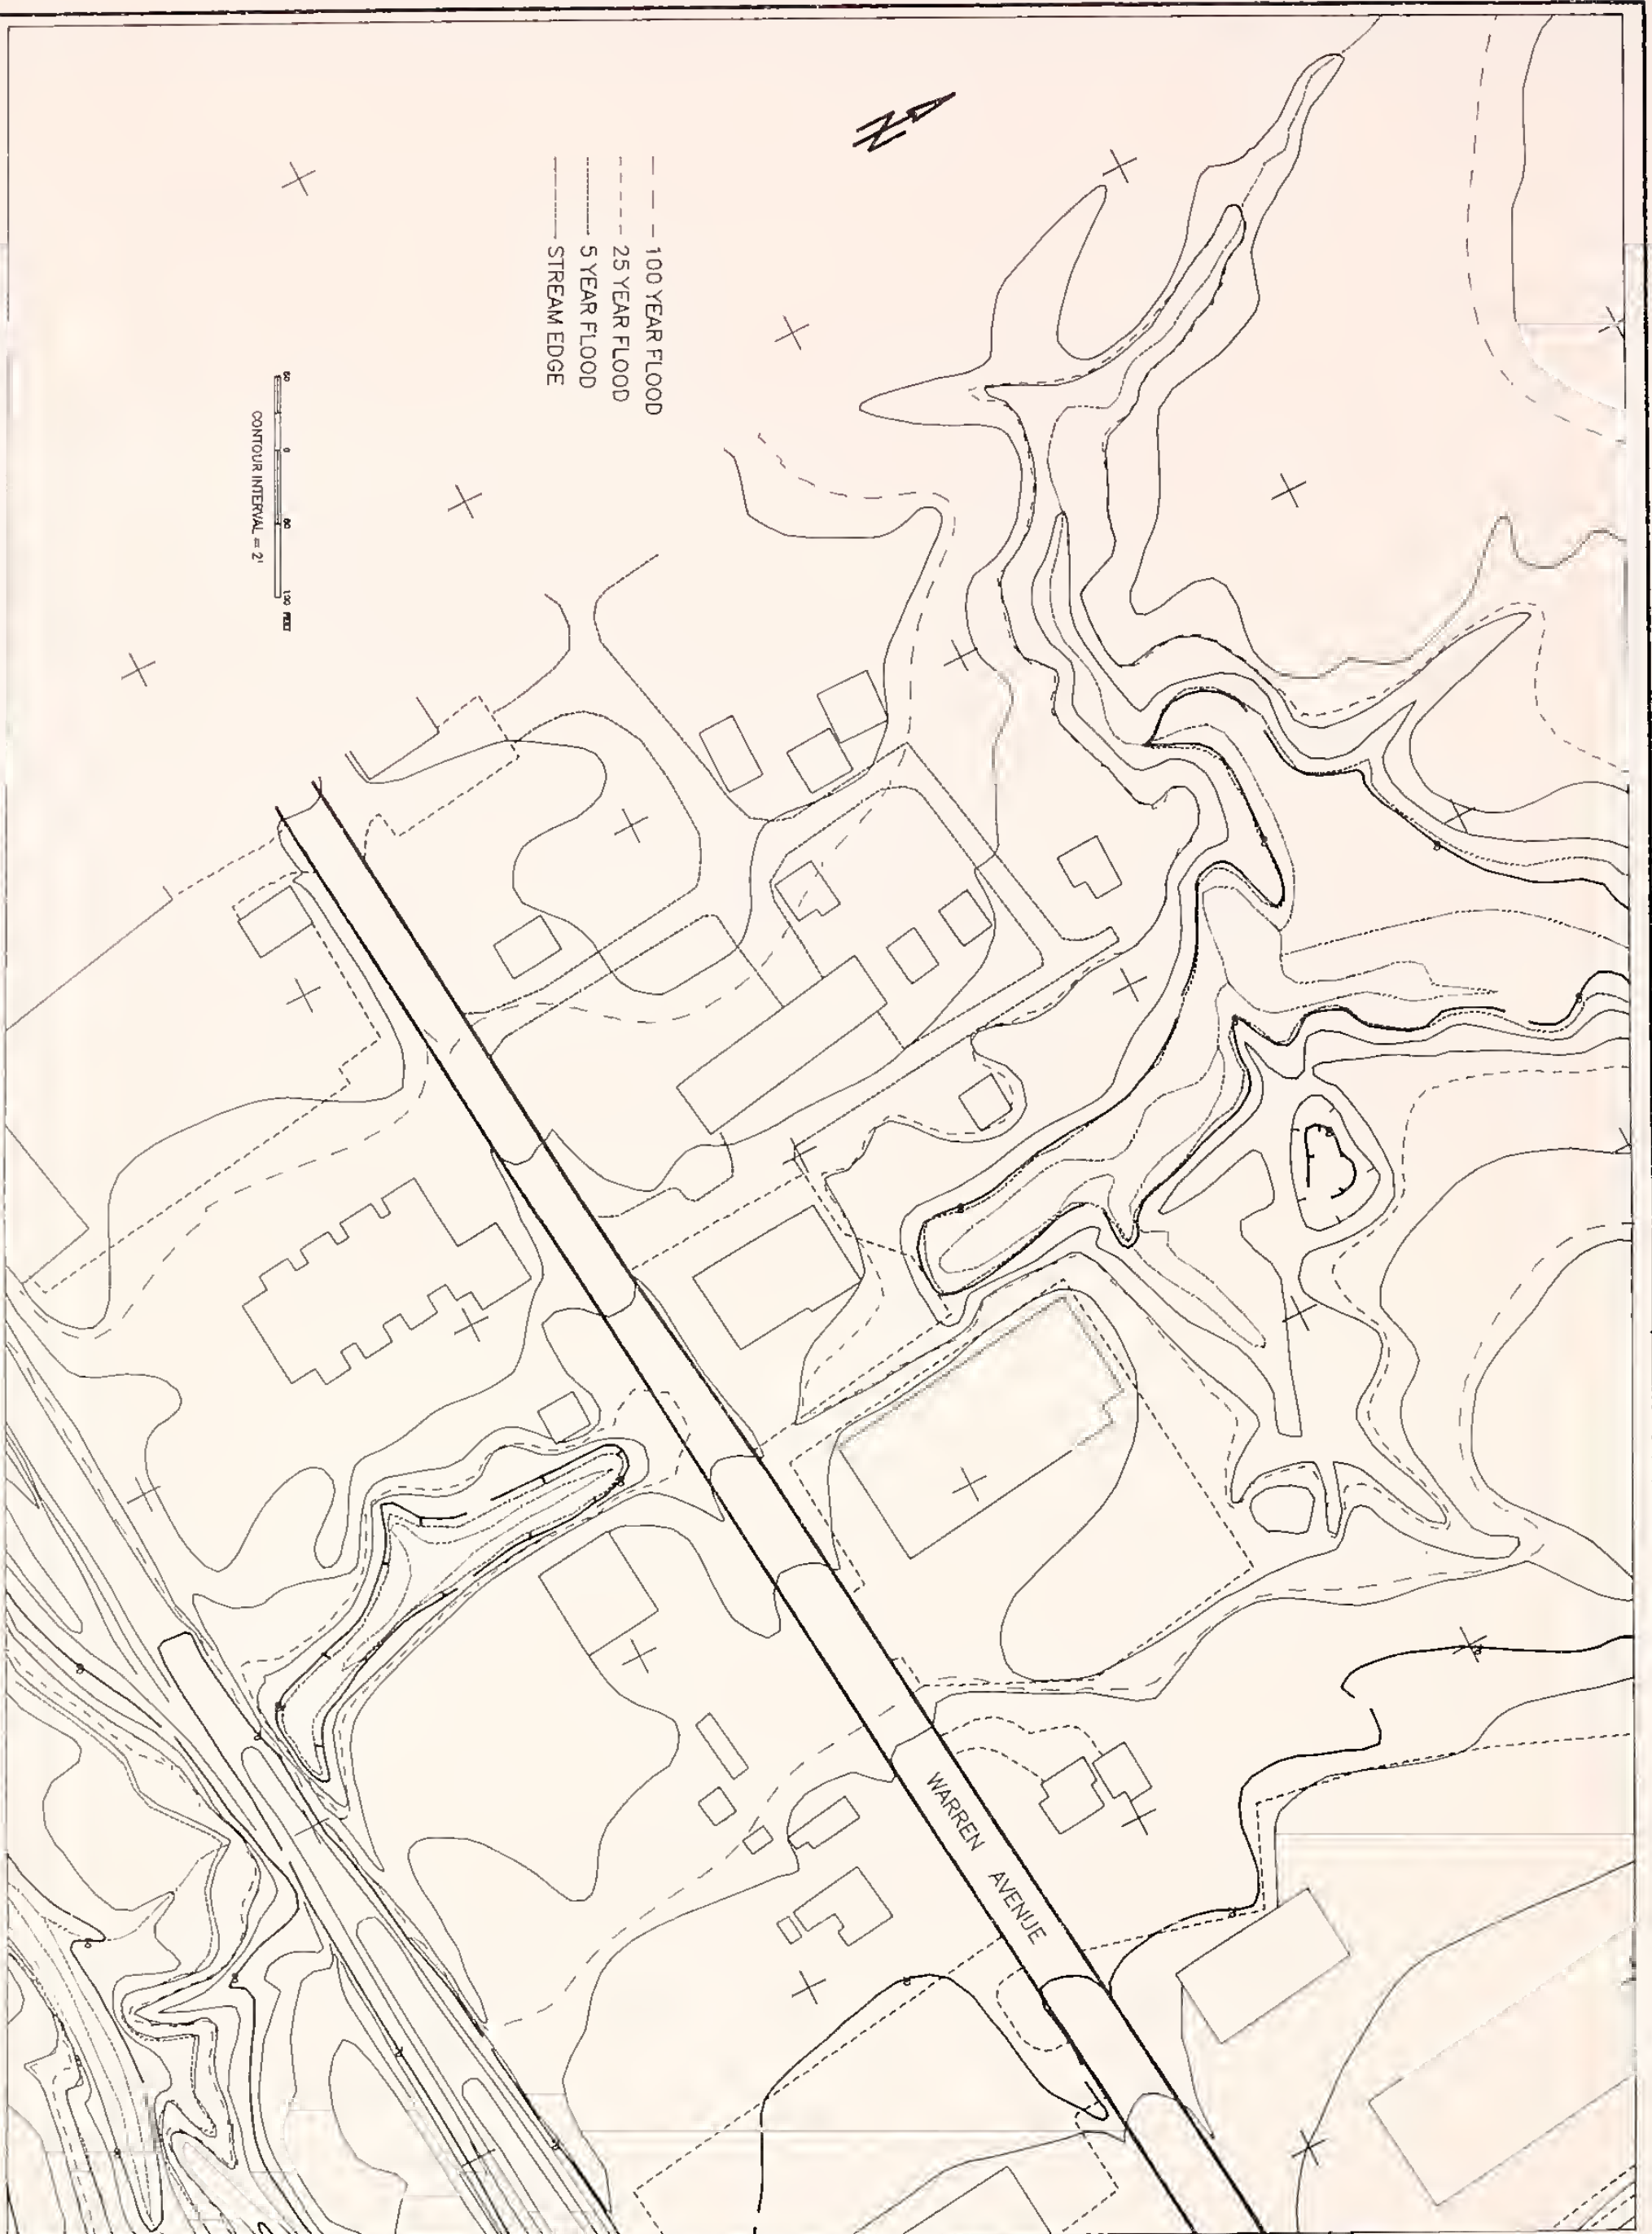
| <div data-bbox="66 2781 96 2904" data-label="Page-Header"><p>SHEET 21</p></div> <div data-bbox="171 2750 655 2919" data-label="Text"><p>NATURAL RESOURCES CONSERVATION SERVICE DURHAM, NEW HAMPSHIRE</p></div> <div data-bbox="183 2959 387 2990" data-label="Text"><p>FEBRUARY, 1995</p></div> | <div data-bbox="836 2750 1225 2842" data-label="Section-Header"><p>CAPISIC BROOK FLOOD PLAIN STUDY</p></div> <div data-bbox="721 2929 1342 3015" data-label="Text"><p>VERTICAL DATUM - NATIONAL GEODETIC VERTICAL DATUM (1929) HORIZONTAL DATUM - MAINE STATE PLANE COORDINATE SYSTEM (WEST ZONE) 500' GRID</p></div> | <div data-bbox="1387 2735 1915 2781" data-label="Text"><p>ORIGINAL DRAWINGS PREPARED BY: AERIAL SURVEY & PHOTO, INC. NORRIDGEWOCK, MAINE</p></div> <div data-bbox="1387 2796 1836 2842" data-label="Text"><p>FROM PHOTOGRAMMETRIC METHODS FROM AERIAL PHOTOGRAPHS DATED 5-15-92</p></div> <div data-bbox="1387 2858 1770 2926" data-label="Text"><p>DIGITIZED BY: CITY OF PORTLAND, MAINE CIVIL & ENVIRONMENTAL WORKS DEPT. ENGINEERING DIVISION</p></div> <div data-bbox="1387 2941 1925 3027" data-label="Text"><p>FLOOD DELINEATION LINES PRODUCED USING GRASS (GEOGRAPHIC RESOURCE ANALYSIS SUPPORT SYSTEM) BY THE NATURAL RESOURCES CONSERVATION SERVICE, DURHAM, NEW HAMPSHIRE</p></div> |
